## MARION NARROWS CHARTLET 13 DECEMBER 2023

THIS INFORMATION HAS BEEN OVERLAID ONTO THE CHART BY MARINE AND SAFETY TASMANIA TO PROVIDE GUIDANCE TO MARINERS ABOUT THE SHIFTING CHANNEL AT MARION NARROWS.

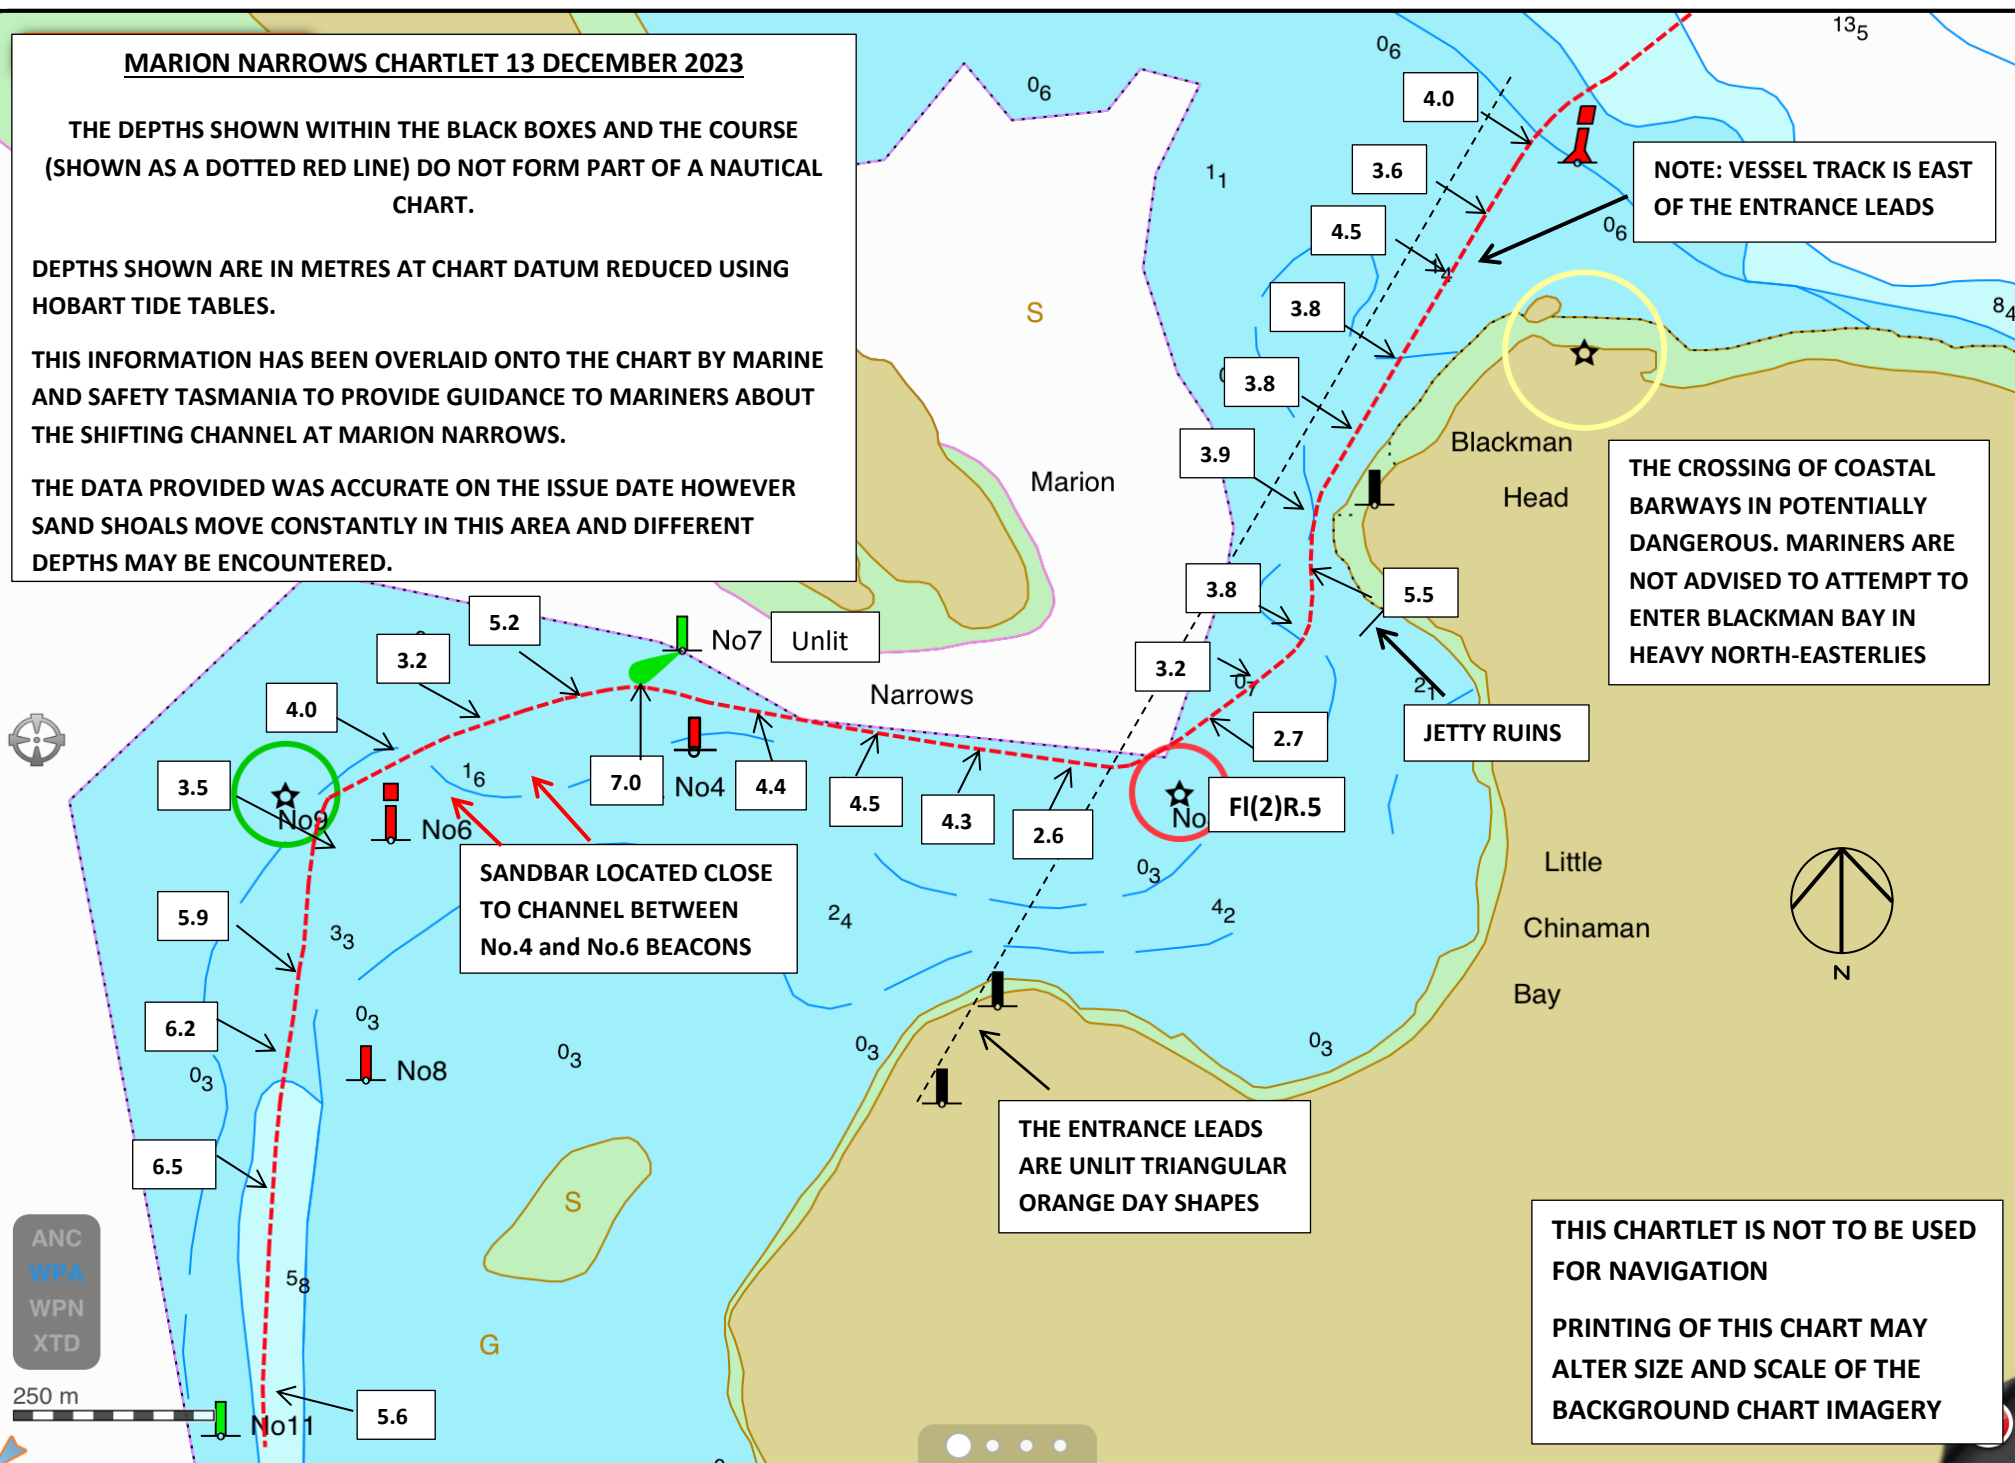
THE DEPTHS SHOWN WITHIN THE BLACK BOXES AND THE COURSE (SHOWN AS A DOTTED RED LINE) DO NOT FORM PART OF A NAUTICAL CHART.

DEPTHS SHOWN ARE IN METRES AT CHART DATUM REDUCED USING HOBART TIDE TABLES.

THE DATA PROVIDED WAS ACCURATE ON THE ISSUE DATE HOWEVER SAND SHOALS MOVE CONSTANTLY IN THIS AREA AND DIFFERENT DEPTHS MAY BE ENCOUNTERED.

NOTE: VESSEL TRACK IS EAST OF THE ENTRANCE LEADS

SANDBAR LOCATED CLOSE TO CHANNEL BETWEEN No.4 and No.6 BEACONS

THE ENTRANCE LEADS ARE UNLIT TRIANGULAR ORANGE DAY SHAPES
