COMMERCIAL BULLETIN

Welcome to Issue 14 of MAST's Commercial Bulletin

Audit of MAST-owned Facilities

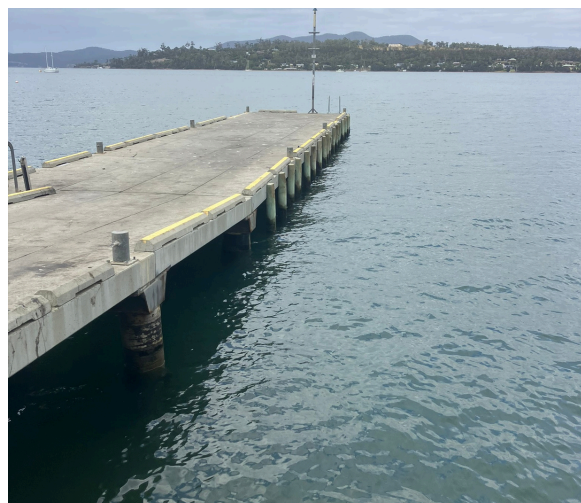
Triabunna Jetty Fendering

MAST is currently assessing options to upgrade the jetty's fendering. The existing timber fender piles are not high or robust enough to adequately protect the structure from some of the larger vessels that berth here. The low deck height also restricts the height of the fender piles.

One option under consideration is the installation of steel fender piles fitted with D-section rubber fenders at each crosshead, extending above the deck level for better protection. Some of the damage to the current fender piles has been caused by vessels exceeding the jetty's berthing limits. Vessel operators are reminded that the maximum displacement limit for vessels using the jetty is 70 tonnes.
